ASBESTOS-CONTAINING MATERIALS ASSESSMENT

For the Building:
4907 HANKIN STREET
Thorsby, AB

Prepared For:
THE TOWN OF THORSBY

MAY 30, 2023
ISSUED FOR USE
FILE: **7695AS01JW**

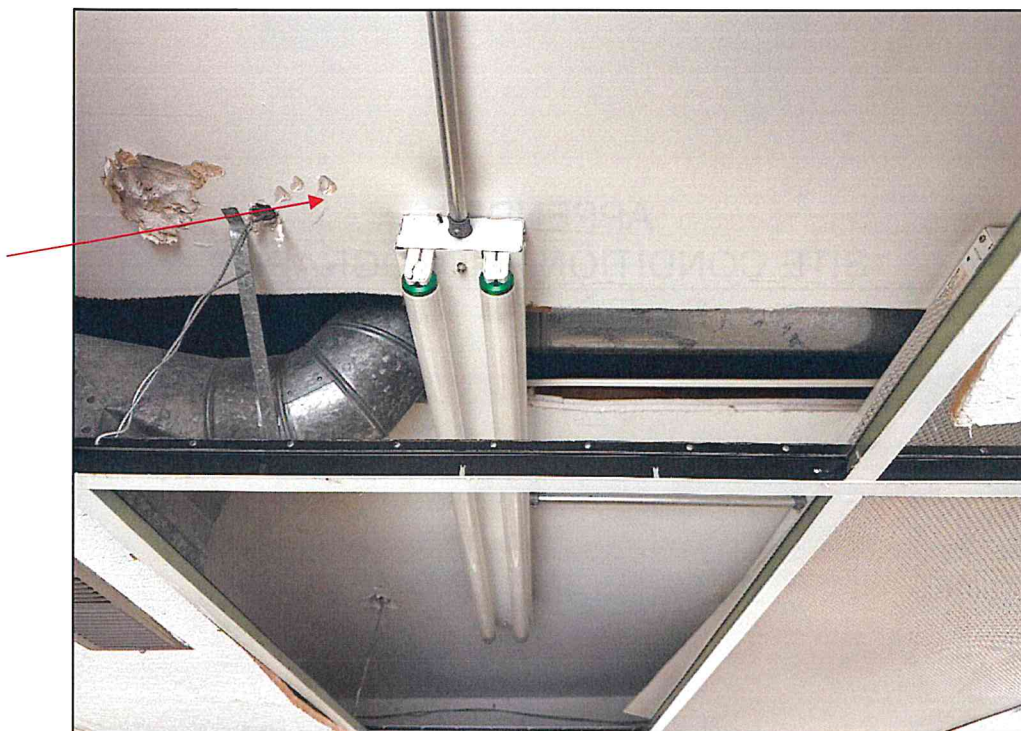
Photograph #1: Asbestos-containing drywall jointing compound – Walls and ceilings throughout Site

The drywall jointing compound identified within various areas throughout the Site returned from the laboratory as **asbestos-containing**. Due to the inconsistent laboratory results and the lack of discernable pattern, CEC recommends that all drywall jointing compound throughout the building be assumed as **asbestos-containing** and should be abated utilizing at least moderate-risk procedures.

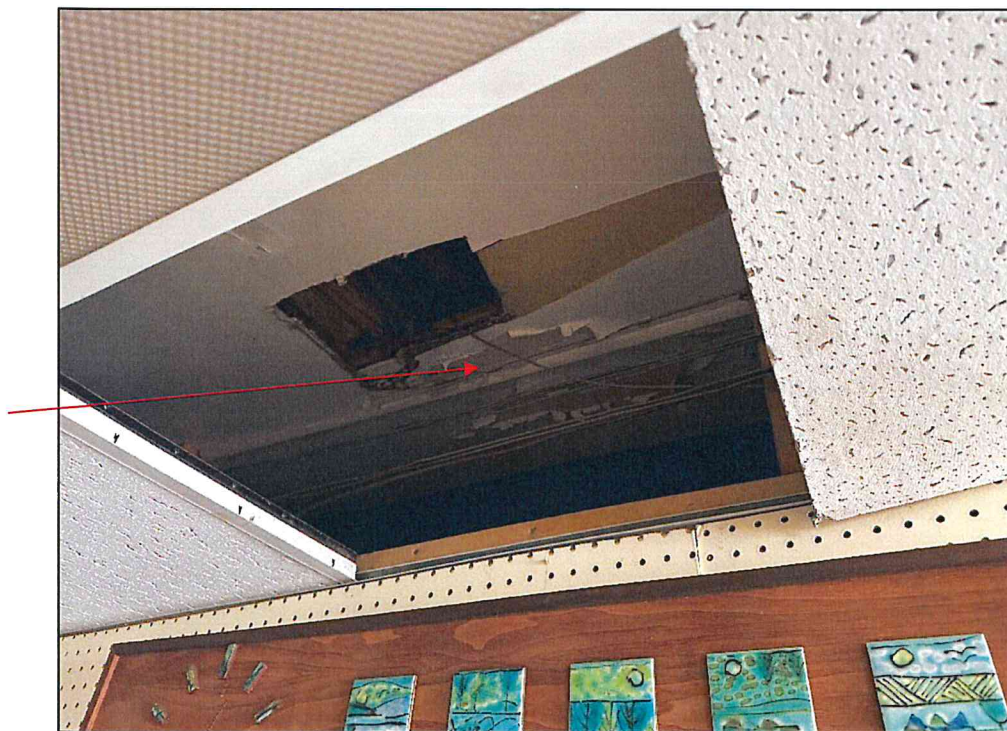
Photograph #2: Asbestos-containing drywall jointing compound – Walls and ceilings throughout Site

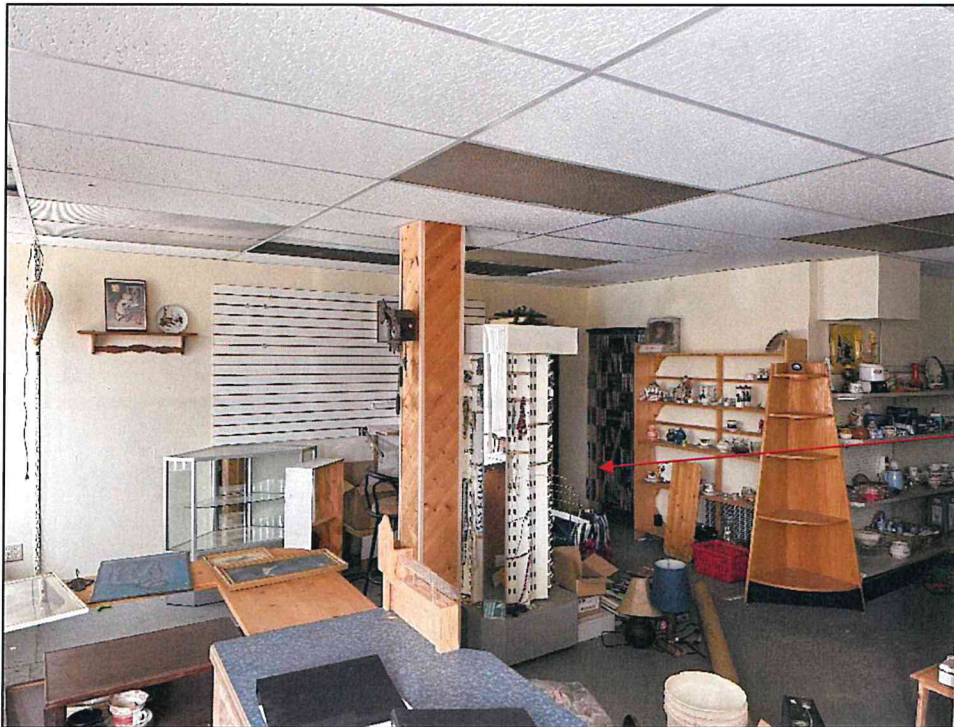
Photograph #3: Asbestos-containing drywall jointing compound – Walls and ceilings throughout Site

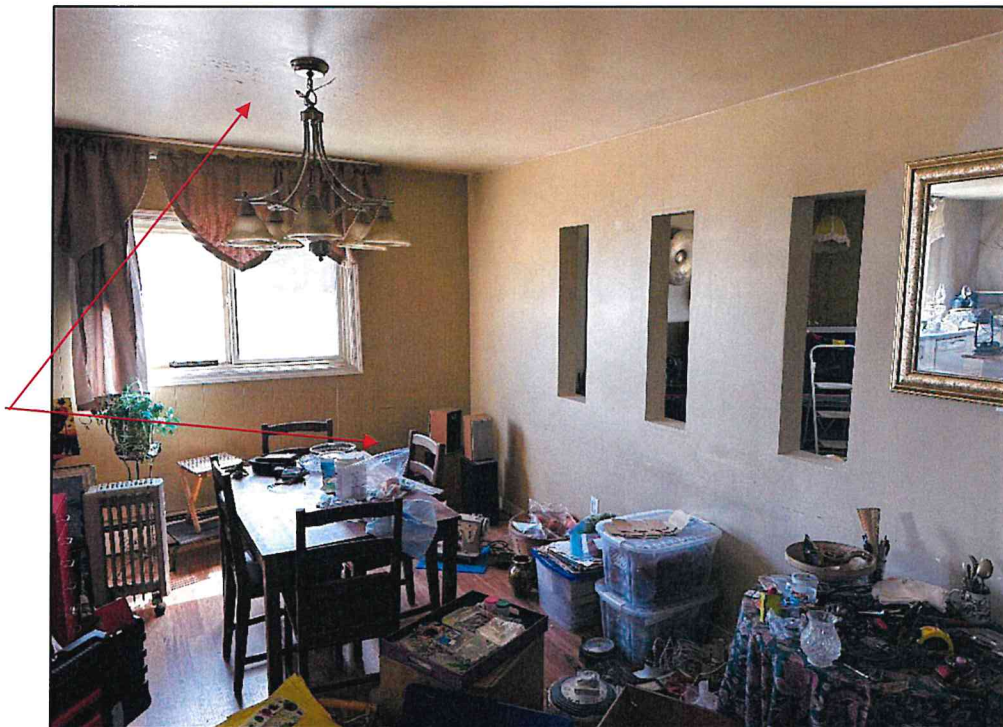
Photograph #4: Asbestos-containing drywall jointing compound – Walls and ceilings throughout Site

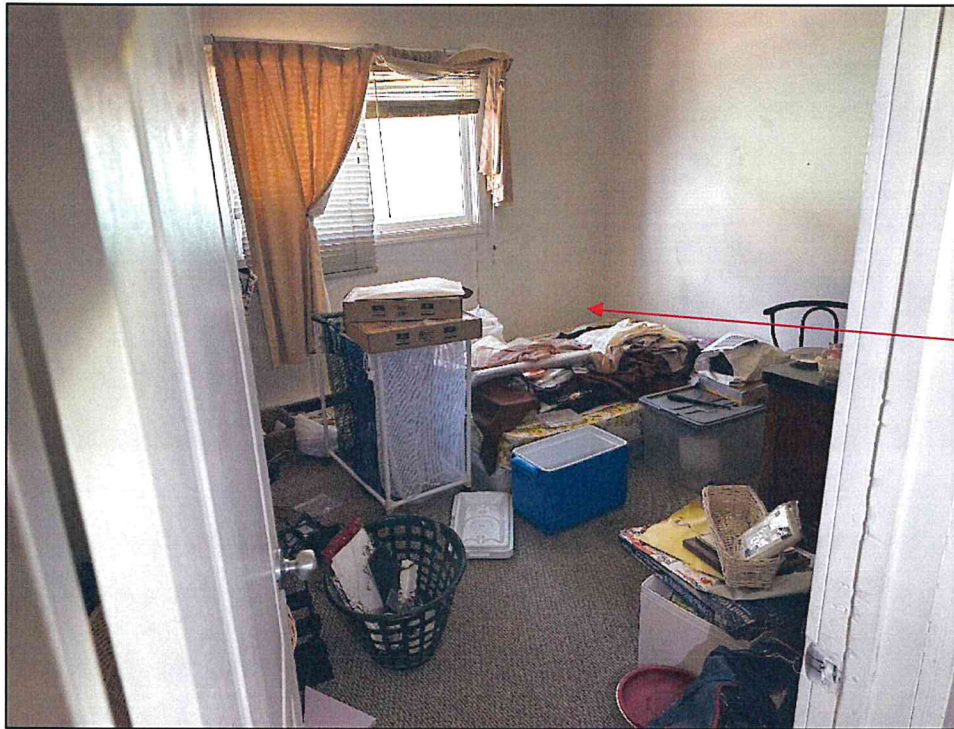
Photograph #5: Asbestos-containing drywall jointing compound – Walls and ceilings throughout Site

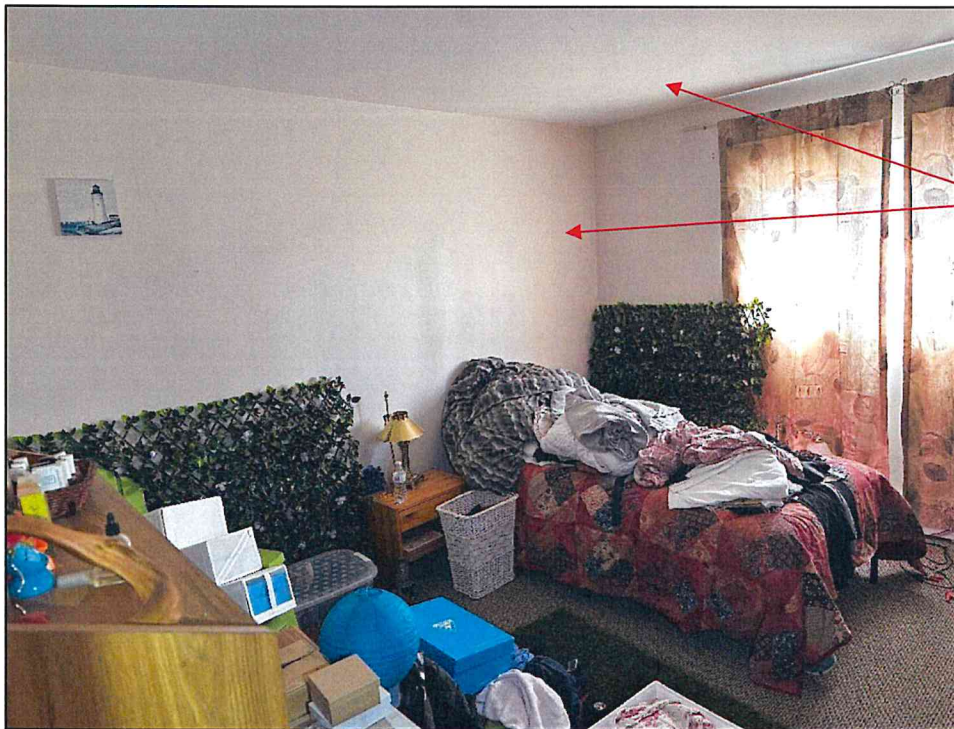
Photograph #6: Asbestos-containing drywall jointing compound – Walls and ceilings throughout Site

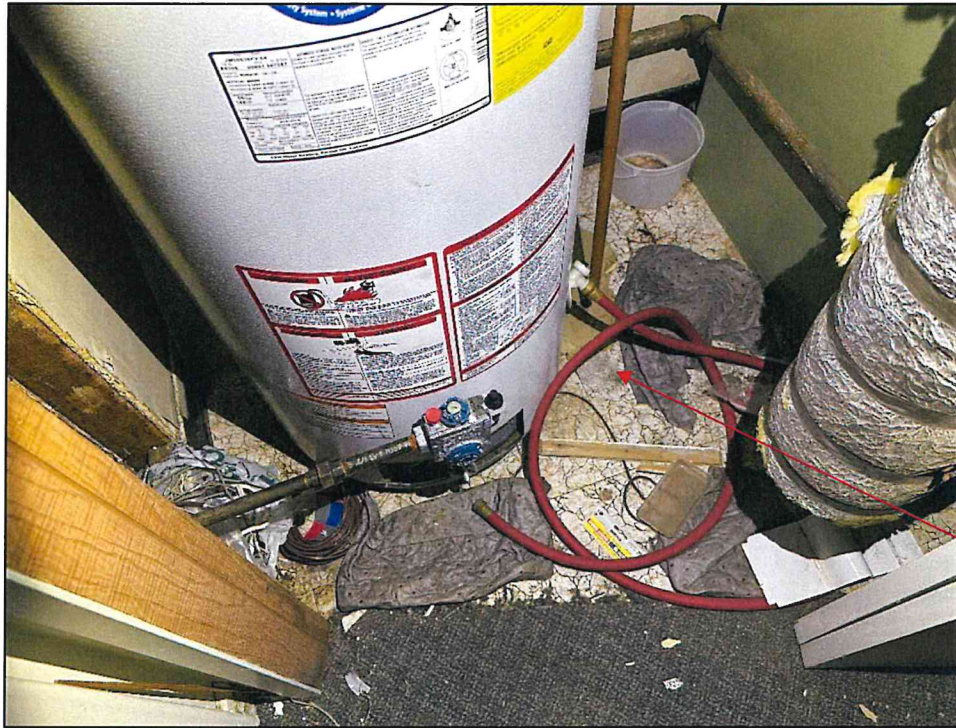
Photograph #7: Asbestos-containing 12" x 12" floor tile (beige w/ gold veins) –
Furnace room and adjacent kitchen area

The 12" x 12" beige w/ gold veins vinyl floor tiles identified within the furnace room and adjacent kitchen area returned from the laboratory as **asbestos-containing** should be removed following low-risk procedures prior to demolition.

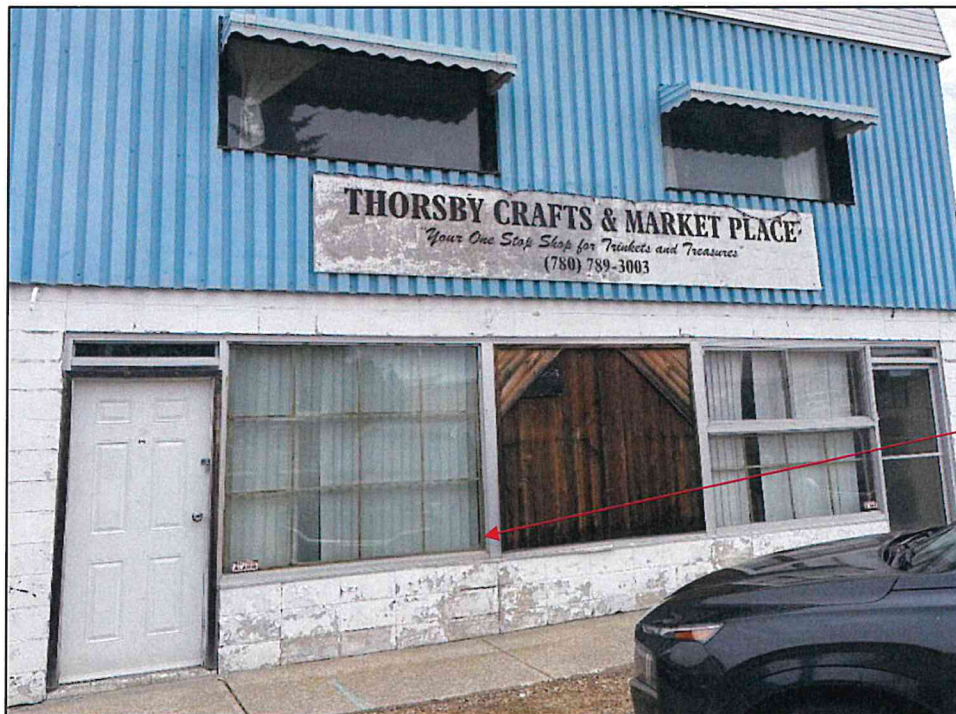
Photograph #8: Asbestos-containing window mastic (white/light grey) – Various
exterior windows

The white/light grey window mastic identified on various exterior windows throughout the Site returned from the laboratory as **asbestos-containing**. This material should be removed following low-risk procedures prior to demolition activities.

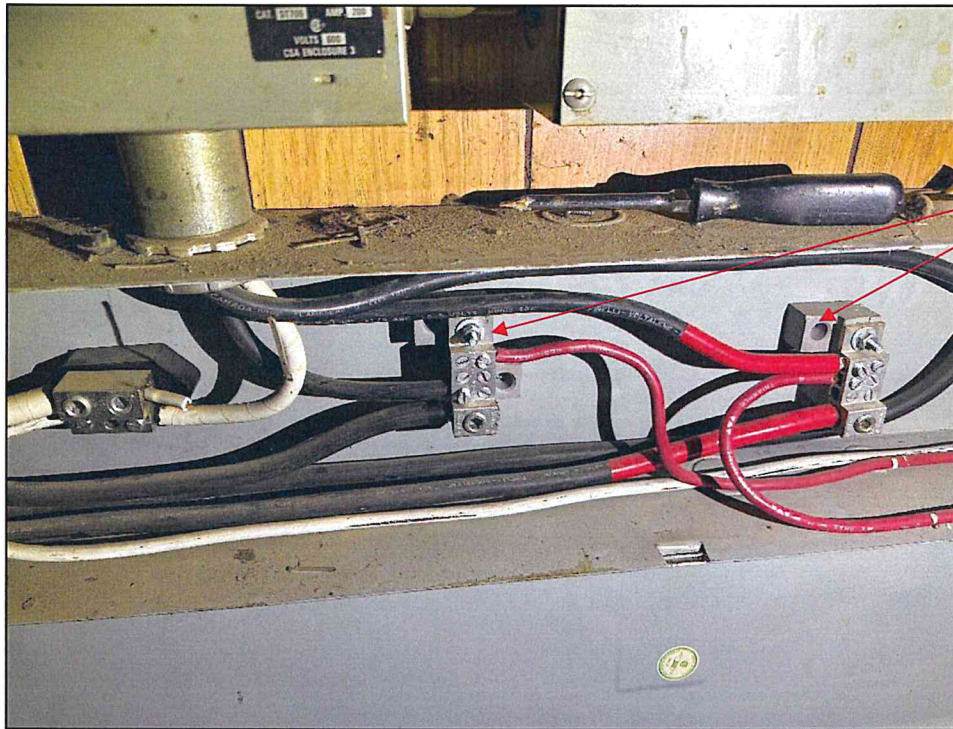
Room or Area	Reason
Transite Blocks in Electrical Cabinets	CEC personnel were unable to collect a sample of the transite blocks within the electrical box within the main floor loading bay due to the exposed wires and hazard risk.

Photograph #9: Presumed asbestos-containing transite blocks – Electrical cabinets in loading bay

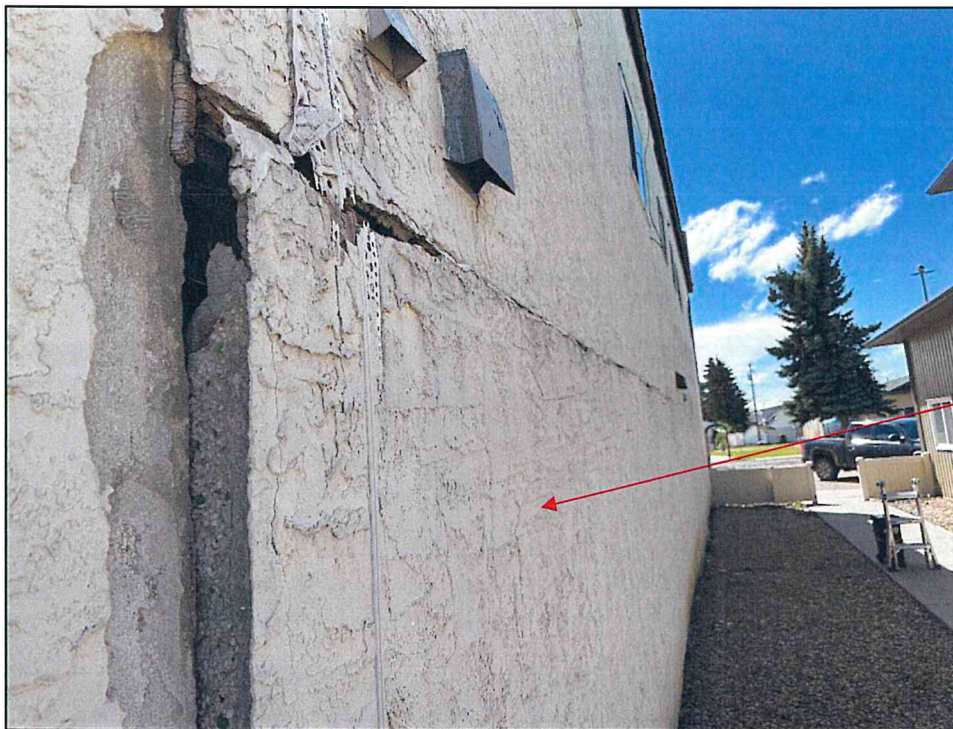
Photograph #10: Non-asbestos-containing stucco – North exterior wall

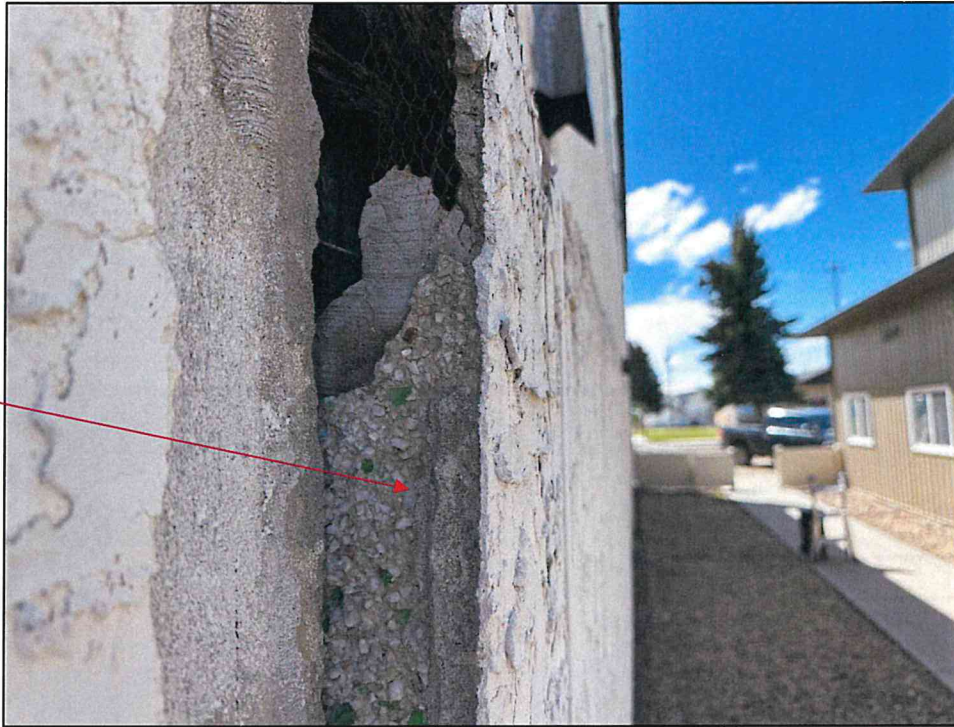
Photograph #11: Non-asbestos-containing stucco w/ green rock dash – North exterior wall

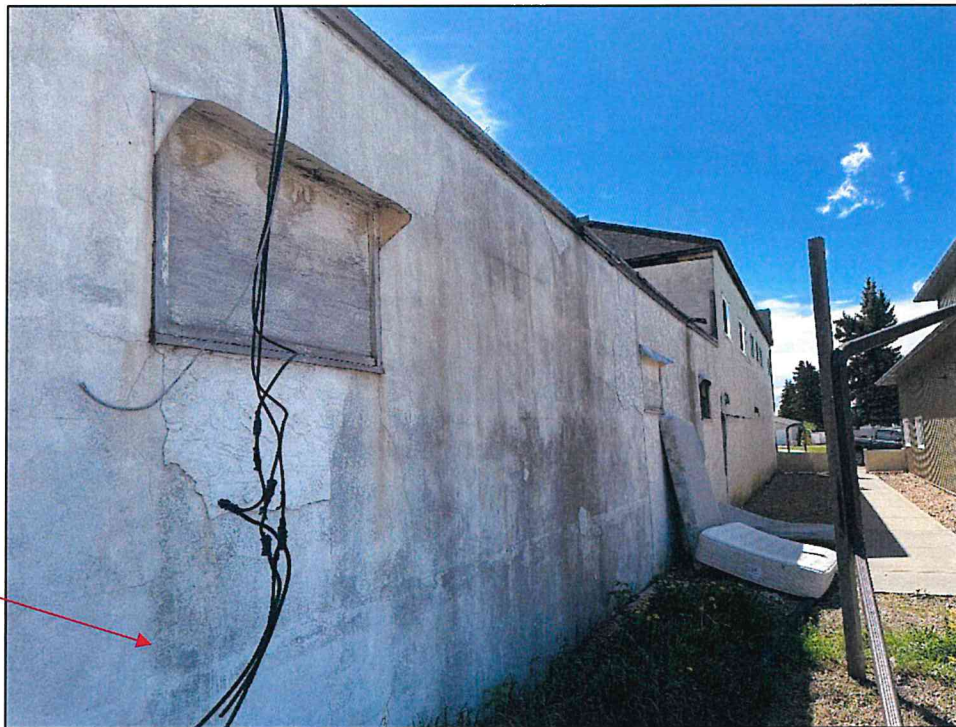
Photograph #12: Non-asbestos-containing grey rough coat stucco – East addition exterior wall

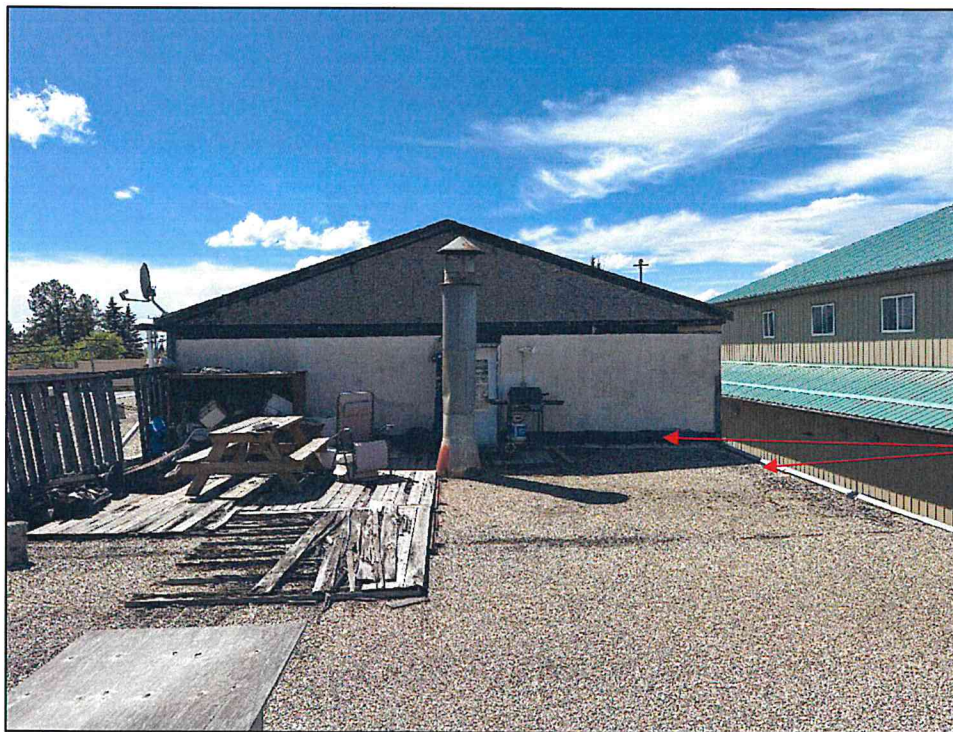
Photograph #13: Non-asbestos-containing roof tar – East roof ledge
